National Transportation Safety Board

Embraer EMB-500
Gaithersburg, Maryland
December 8, 2014

Investigator-in-Charge
Presentation

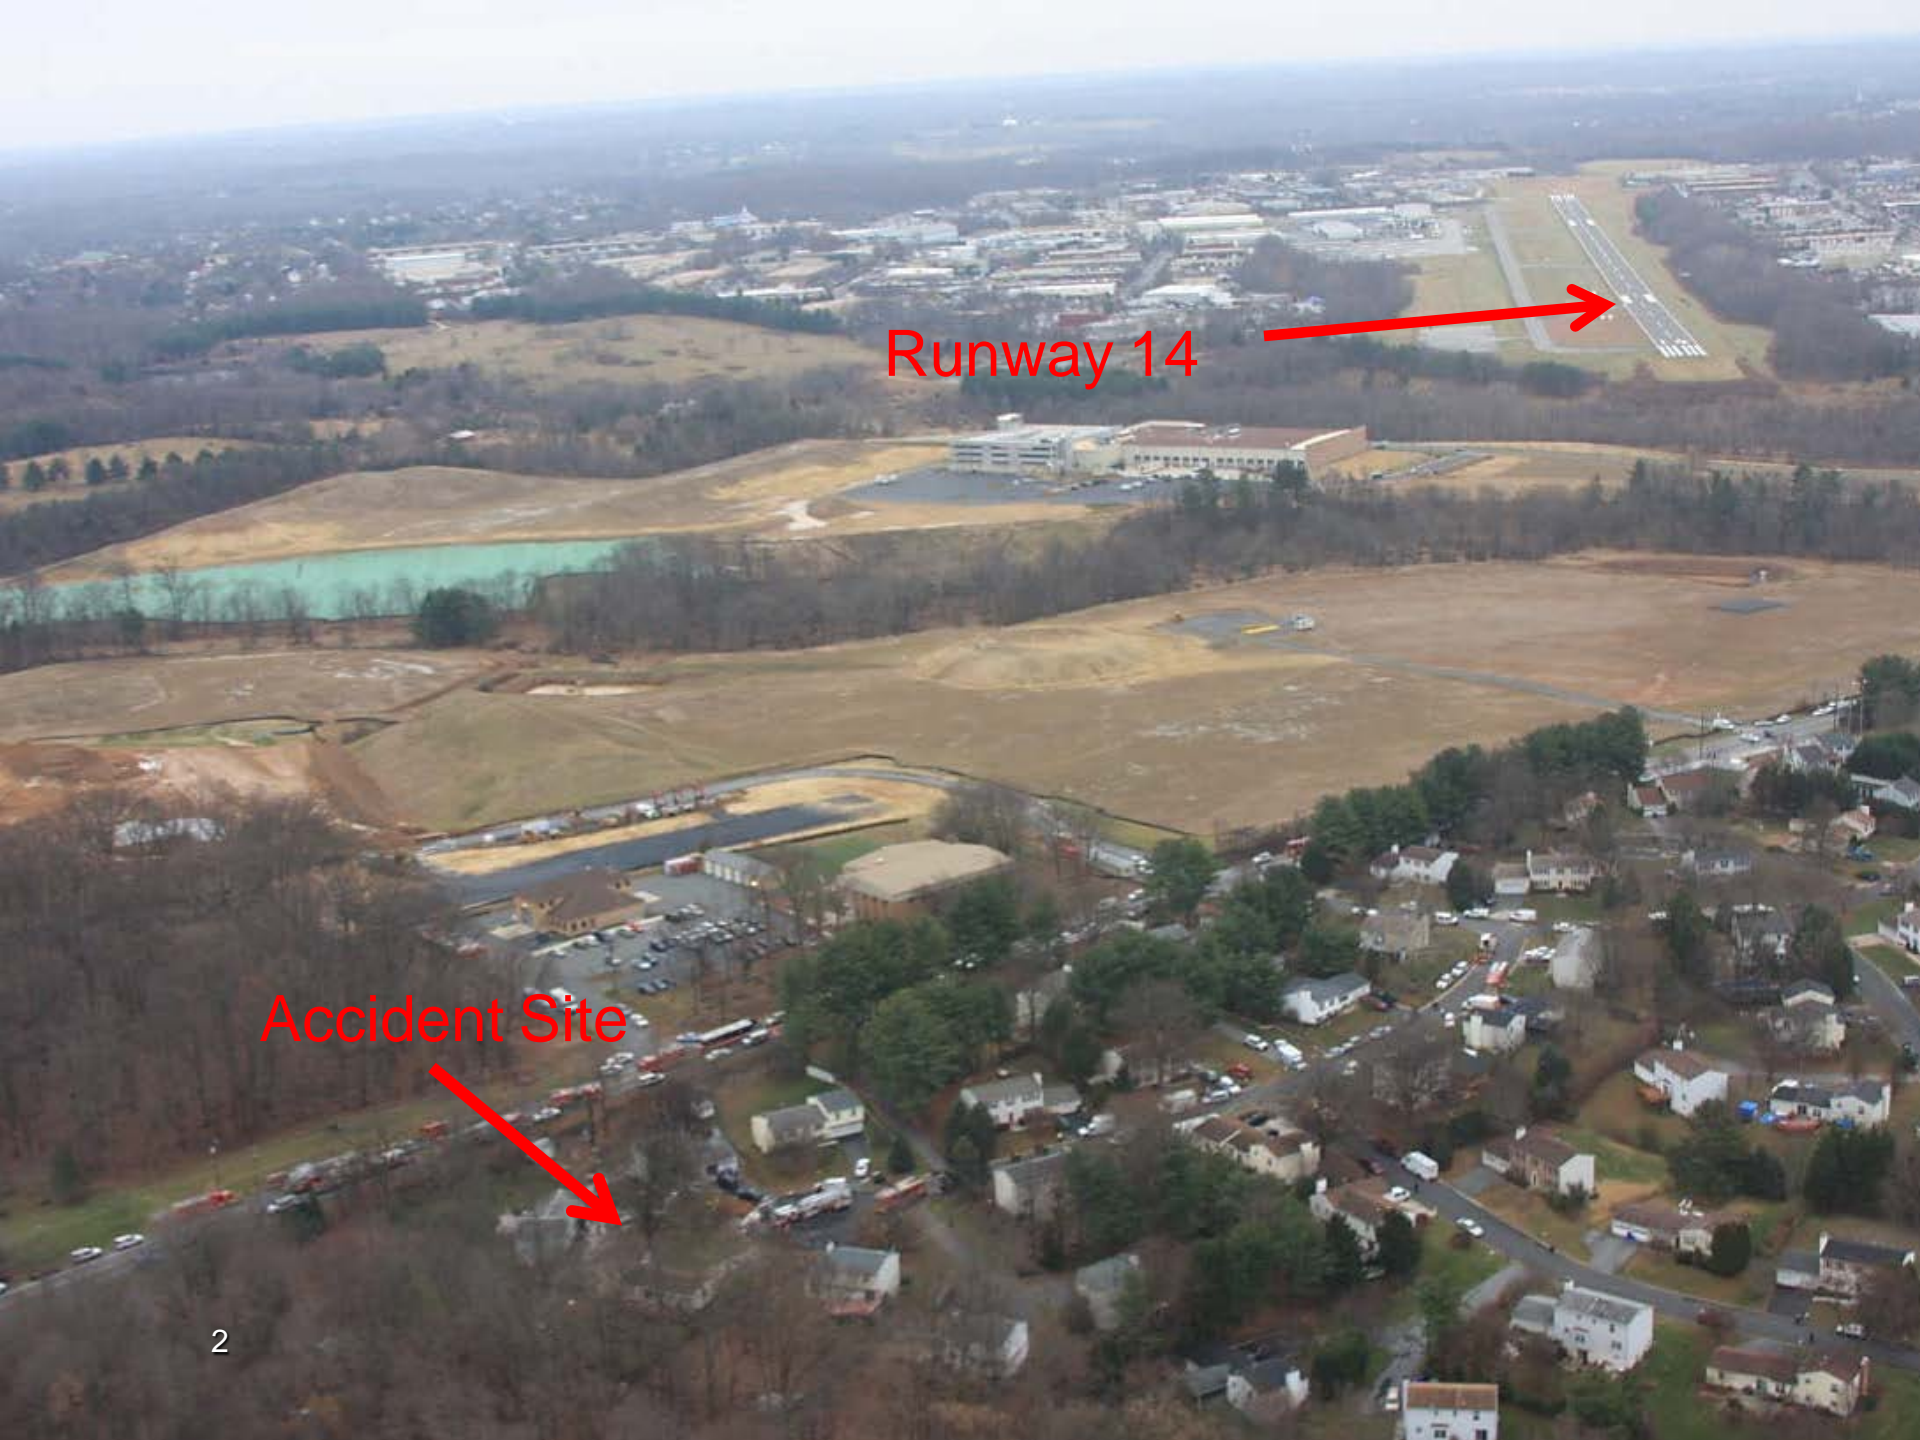
Accident Site

- Pilot, 2 passengers and 3 people in the house fatally injured
- Instrument flight rules
- Operated under Part 91
- Go-team – launched

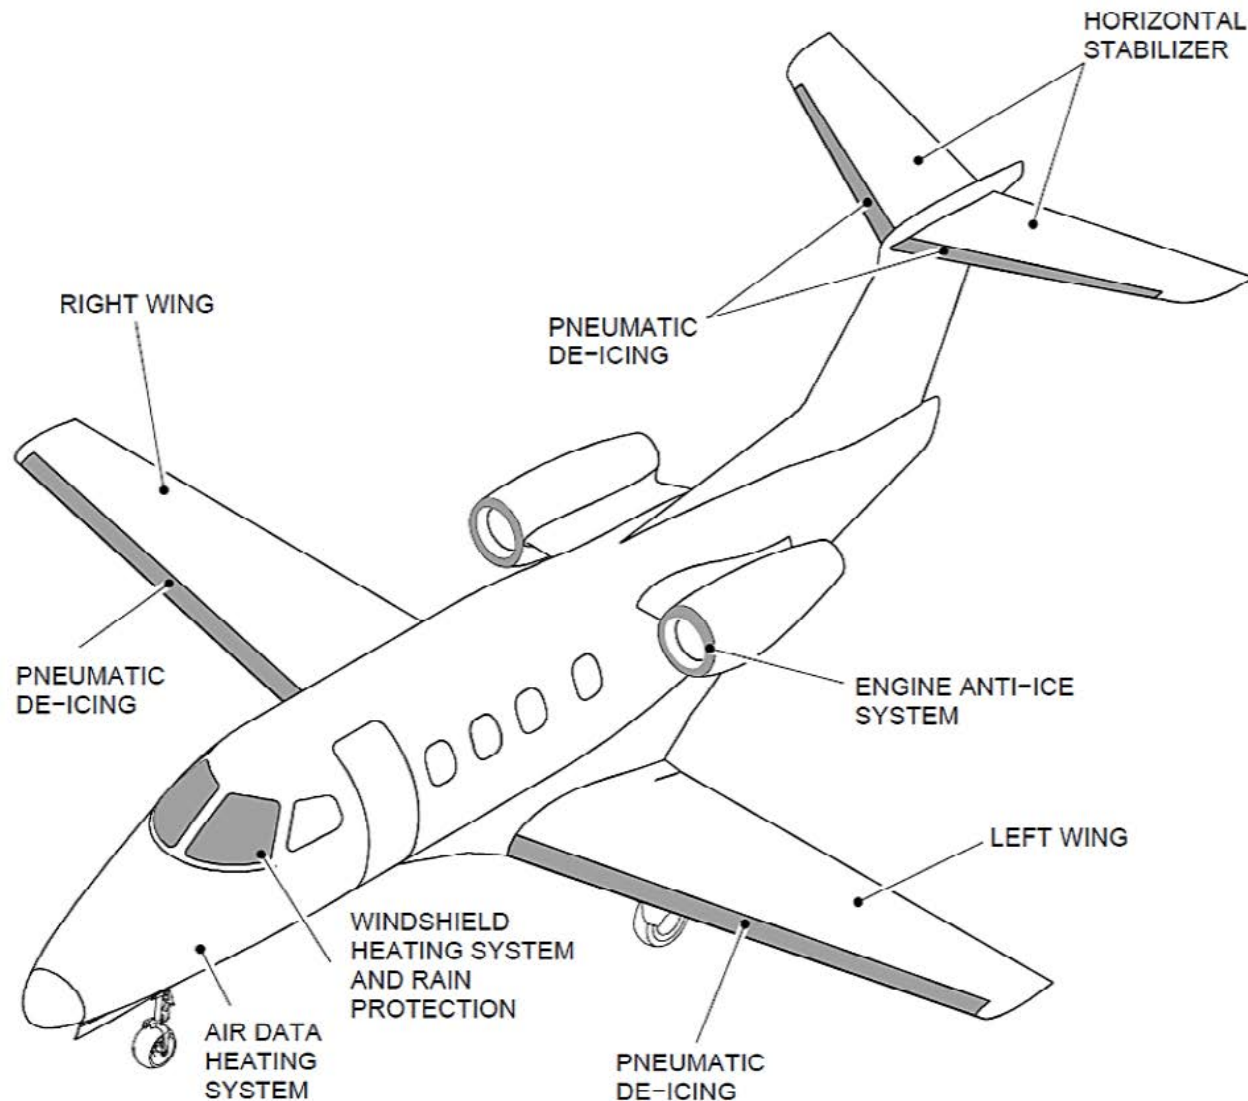
EMB-500 – Certified for Icing

- Pitot-Static System Heat – ON
- Engine anti ice system - OFF
- Wing / horizontal stabilizer deice boot system – OFF
- Resultant: Stall at low altitude
